SIB 63 04 18

DAYTIME RUNNING LIGHT IS DIM OR DISCOLORED

This Service Information Bulletin (Revision 2) replaces SI B63 04 18 dated January 2019.

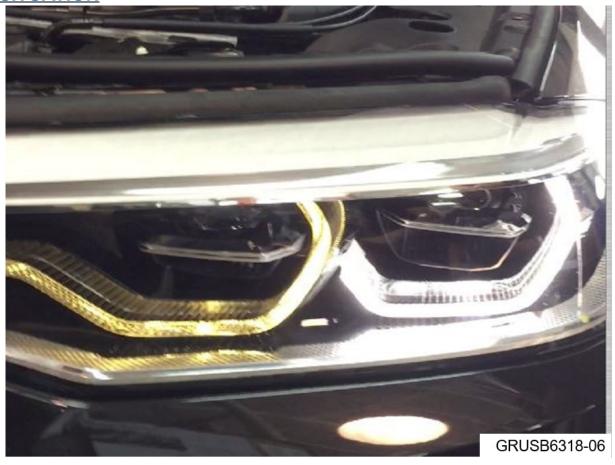
GRUSB6318-07

One or more of the LED daytime running lights are dim or discolored.

The connection between the LED module and light tube inside the headlight is damaged.

2. Inspect the LED module for signs of discoloration as seen to the left. If discoloration is present, inspect the light tube of the headlight for signs of discoloration.

Inspect and replace the affected LED module. Replace the headlight only if internal damage is found to the light tube.

<u>Discoloration is present only on the LED module</u>- Replace the affected LED module only, following ISTA/AIR repair instructions based on the vehicle model.

<u>Discoloration is present on the LED module AND the light tube</u>: Replace the complete headlight and the LED module, following ISTA/AIR repair instructions based on the vehicle model.
